CERTIFICATE OF TITLE 5 INSPECTION

Commonwealth of Massachusetts Title 5 Official Inspection Form

89 Sherburne Ave				
	Property Address				
	Ed Dehoratius				
Owner information is required for every	Owner's Name				
	Tyngsboro	MA	01879	10/06/2020	
page.	City/Town	State	Zip Code	Date of Inspection

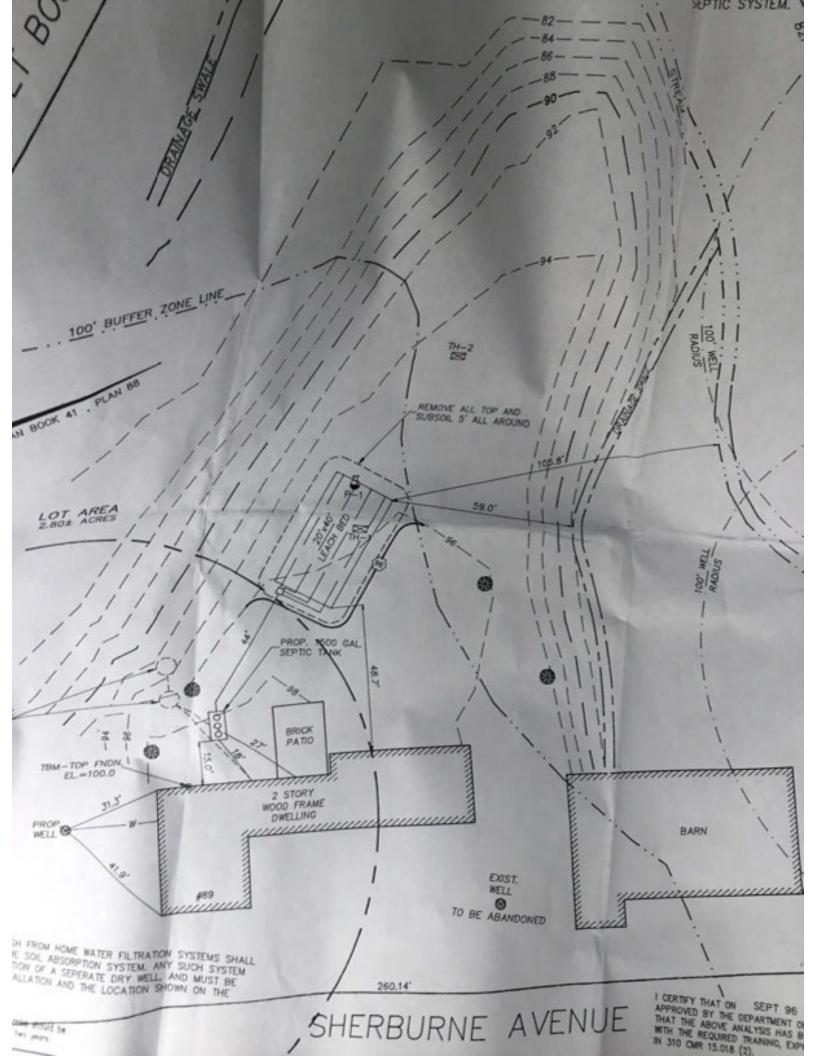
S	OIL TEST	
DEEP TEST	TH-1	TH-2
ATE	3/20/02	3/20/02
ROUND ELEV.	95.9	95.1
A	0"-8" FSL 10YR3/2	0"-7" FSL 10YR4/3
Rw	8"-18" LS 10YR5/6	7"-18" LS 10YR6/8
C1	18"-54" COARSE S&G 2.5Y6/4	18"-60" F-M SAND 2.5Y7/3
01	LOOSE-SINGLE GRAIN	MASSIVE-VERY FRIABLE
C2	54"-126" F-M SAND 2.5Y7/3	60"-120" COARSE S&G 2.5Y6/
	MASSIVE-VERY FRIABLE	LOOSE-SINGLE GRAIN
	NO E.S.H.W.T.	NO E.S.H.W.T.
	NO WEEPING	NO WEEPING
	NO OBS. WATER	NO OBS. WATER
	Contraction of the local division of the loc	1
CONDUCTED BY	NOPSE	RICK - T.B.O.H. ENVIRONMENTAL SERVICES INC.
CONDUCTED BY DEEP TEST DATE GROUND ELEV.	JEFF HANNAFORD - NORSE	ENVIRONMENTAL SERVICES INC.
CONDUCTED BY DEEP TEST DATE GROUND ELEV.	Y NORSE ENVIRONMEN	ITAL SERVICES INC.
CONDUCTED BY DEEP TEST DATE GROUND ELEV.	Y NORSE ENVIRONMEN BY P-1 TEST 3/20/02	ENVIRONMENTAL SERVICES INC.
CONDUCTED BY DEEP TEST DATE GROUND ELEV.	PY NORSE ENVIRONMEN BY NORSE ENVIRONMEN BY P-1 TEST 3/20/02 24 GAL.<15 MIN. RATE <2 MIN./INCH	ENVIRONMENTAL SERVICES INC.

CONDUCTED BY DEEP TEST DATE GROUND ELEV.	PY NORSE ENVIRONMEN BY P-1 TEST 3/20/02 24 GAL.<15 MIN. RATE <2 MIN./INCH 48"	ENVIRONMENTAL SERVICES INC.
CONDUCTED BY DEEP TEST DATE GROUND ELEV. WITNESSED B CONDUCTED PERCOLATION DATE SATURATION 12" - 9" 9" - 6" STABILIZED	AY NORSE ENVIRONMEN BY NORSE ENVIRONMEN BY P-1 TEST 3/20/02 24 GAL.<15 MIN. RATE <2 MIN./INCH 48" by K. FILZE	ENVIRONMENTAL SERVICES INC.

and the second second second			
ITNESSED BY	The second s		
CONDUCTED BY	NORSE ENVI	RONMENTAL SERVICE	S INC.
PERCOLATION TEST	P-1		
DATE	3/20/02	2	
SATURATION	24 GAL.<15	and the second	
12" - 9"			
9" - 6"			
STABILIZED RATE	<2 MIN./IN	ICH	
DEPTH	48"		
WIINESSED BY	К.	FITZPATRICK - T.B	.O.H.
CONDUCTED BY	JEFF HANNAFORD) - NORSE ENVIRONME	NTAL SERVICES IN
3	SCHEDULE O	F ELEVATIONS	A THE
LOCATIO		PROPOSED	AS-BUILT
TOP OF FOUNDATI	ON	100.00	100.00
FOUNDATION OUT	INVERT	95.5±	95.5±
CLEANOUT INVERT	- I -		95.22
SEPTIC TANK IN IN	NVERT	94.90	94.96
SEPTIC TANK OUT		94.65	94.60
DISTRIBUTION BOX	and the second se	92.72	92.86
DISTRIBUTION BOX		92.55	92.69
BEGINING OF LATER.	ALS INVERT	92.45	92.61

92.62
			92.69
END OF LATERALS I	NIVERT	92.25	92.61
LIND OF LATERALS I	NVENT	92.20	92.36
	and the second se		92.39
	Party and a second second		92.38 92.38
BOTTOM OF BED ELE	TV	91.75	91.86
SED LLI	· ·		51.00
KEY	and the second sec	LOC	US
EX	STING GRADE	RECEN	/ED
	OPOSED GRADE	A Blass & Errall D	1 Gald

SEPTIC TANK IN INVERT	94.90	94.96
SEPTIC TANK OUT INVERT	94.65	94.60
DISTRIBUTION BOX IN INVERT	92.72	92.86
DISTRIBUTION BOX OUT INVERT	92.55	92.69
BEGINING OF LATERALS INVERT	92.45	92.61
		92.62
		92.69
	1 de la compañía de	92.61
END OF LATERALS INVERT	92.25	92.36
		92.39
		92.38
		92.38
BOTTOM OF BED ELEV.	91.75	91.86
KEY	LOCUS	2
EXISTING GRADE	RECEIVE	ED
PERCOLATION TEST DEEP TEST	OCT 2 9 2002	
TBM BENCHMARK	BOARD OF HE	ALTH
SUBSURFACE SEWAG	E DISPOSAL S	YSTEM
3 Pondview Tyngsboroug (978) 649-	gh, MA 01879 9932	s Inc.
LOCATION: #89 SHERBURNE AVE TYNGSBORO, MA.	OWNER: RICHARD BO #89 SHERBURN TYNGSBORO,	E AVE
ASSESSORS MAP #27 PARCEL #12 DATE 4/09/02 SCALE 1" = 20'	DWG-NO 3635 SHEE	T 1 OF 2
